Enhanced Preliminary Assessment Report:

Old Bridge Army Housing Units
Old Bridge, New Jersey

November 1989

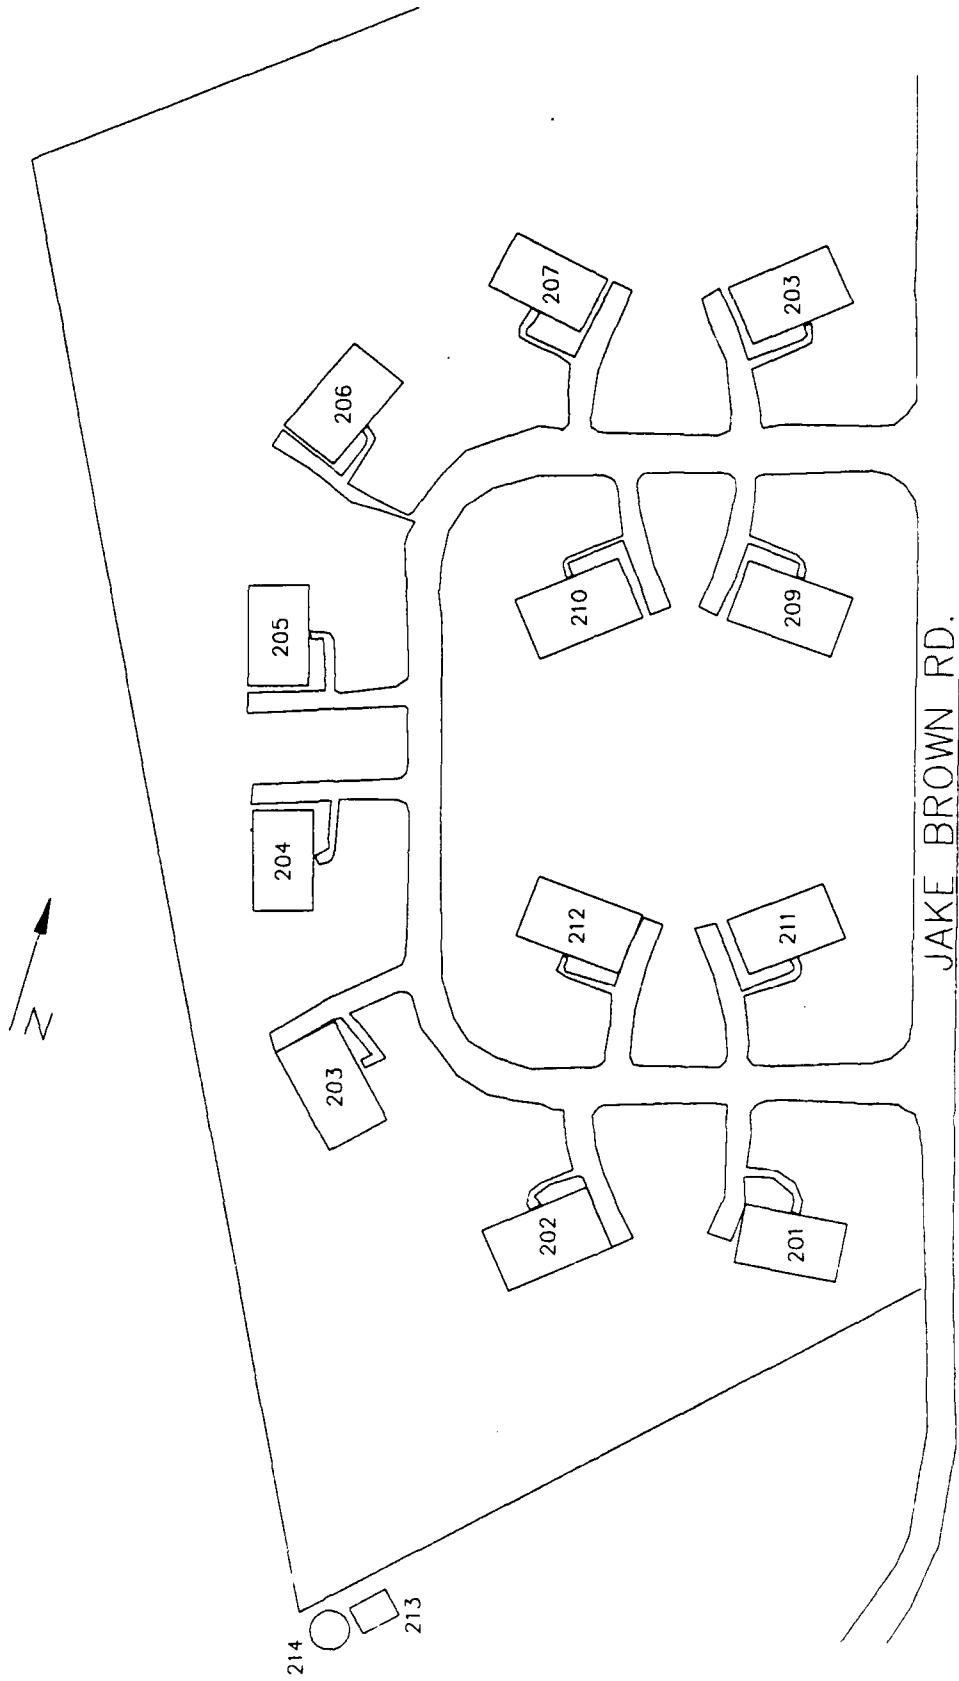
FIGURE 3 Site Plan Map of Old Bridge Army Housing Units

Figure 3 presents the site plan of the Old Bridge housing area.

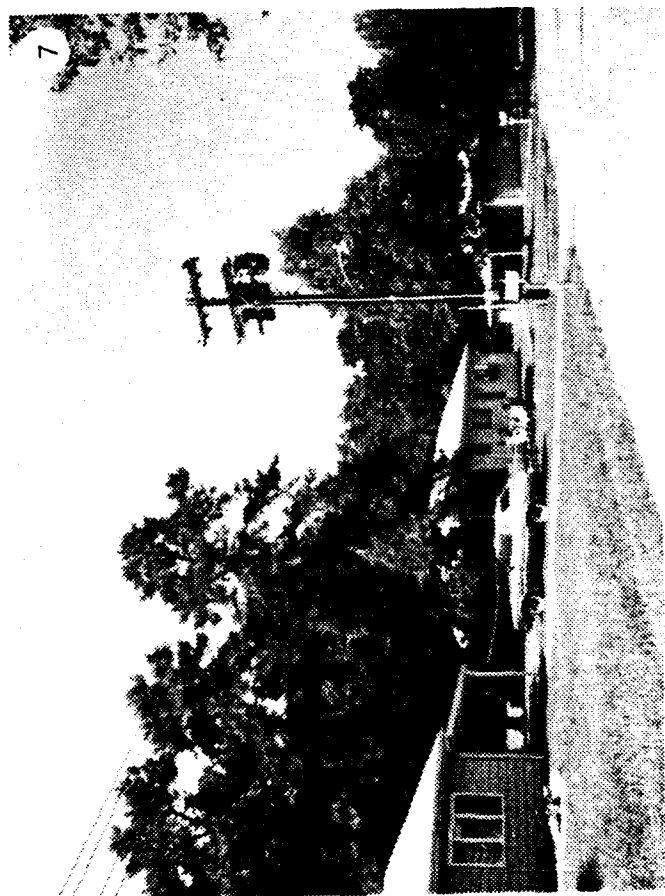
7. Utility pole and transformers in front of housing units.
8. Sanitary sewer manhole and a culvert seen here.
9. At the bottom left is the sanitary sewer lift station; station is across the street from the manhole shown in the previous picture.

Electrical transformers on-site should be inspected for possible leakage. It is also recommended that on-site transformers, as well as the soil at the base of transformer poles, be tested for the presence of PCBs; that the contents of the transformers be labeled; and that any contamination found be remediated as required.

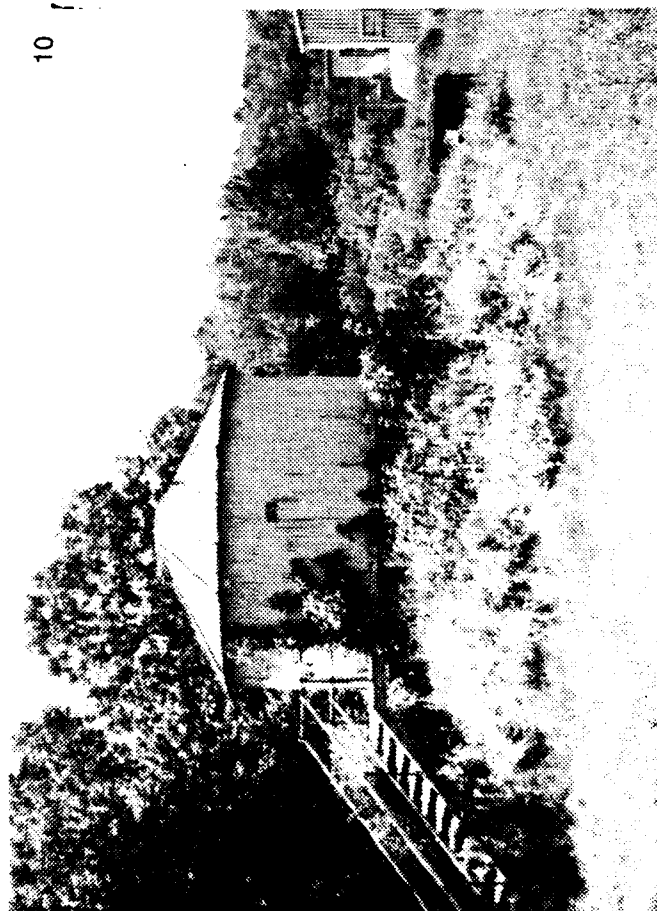
10. An old sewage-treatment facility, located about 0.5 mile down the road from the housing site, in the former fire-control area of the old Nike battery.

As indicated earlier, the sewage-treatment facility that services the Old Bridge housing area is located nearby, on land once part of the fire-control area associated with the Nike battery. Although no records still exist to show the details of the connections, it is likely that the old treatment plant serviced the fire-control area as well as the housing area. A lift station, located just across Jake Brown Road from the housing area, is used to pump wastewater from the housing area to the treatment plant. Although the topography is relatively flat, the possibility exists that missile-related contaminants may have migrated along the buried sewer lines from the treatment plant to the housing area.

Since the housing area is connected by buried utility lines to land that was at one time part of the Nike battery's fire-control area, it is recommended that soil from along these lines be tested for the presence of missile-related wastes.
